**Flood Control Project Maintenance
Levee Inspections**
LMA District Cover Sheet
Spring 2017 Levee Inspection Results

Sutter Maintenance Yard Maintenance Area 0001

Spring 2017 Levee Inspection Results

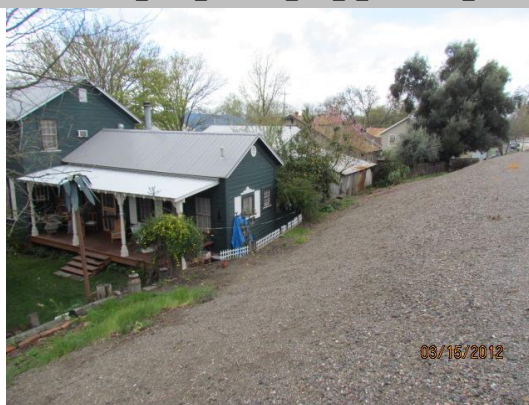
Photo 1 of 1 : SP_2017_MA0001_297_2_20170315_00001.jpg

LM Start	0.04	Rating **	U	Issue No.	2
LM End	0.23	Issue Type +	En	Location *	LS
Category	Earthen Levee			GPS Latitude/Longitude	
				Start	End
Item	Encroachments			39.213988 °	39.215198 °
				-122.001537 °	-122.004775 °
DWR ID	DWR_MA0001_01_s_2012_2				
Comment Code					
BU : Building					
Inspector Comment

View of the building along the landside toe.

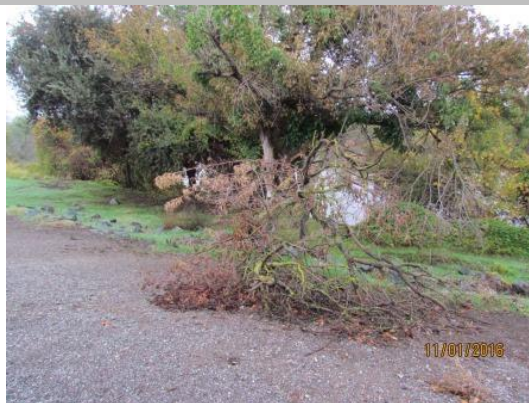
Photo 1 of 1 : SP_2017_MA0001_297_93_20170315_00026.jpg

LM Start	0.07	Rating **	M	Issue No.	93
LM End	0.07	Issue Type +	En	Location *	WS
Category	Earthen Levee			GPS Latitude/Longitude	
				Start	End
Item	Encroachments			39.214162 °	39.214162 °
				-122.002158 °	-122.002158 °
DWR ID	DWR_MA0001_01_f_2016_93				
Comment Code					
TR : Tree or limb					
Inspector Comment

View of a tree limb along the waterside slope.

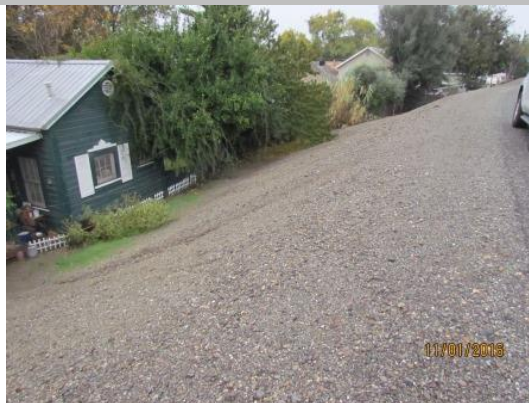
Photo 1 of 1 : SP_2017_MA0001_297_94_20170315_00027.jpg

LM Start	0.09	Rating **	M	Issue No.	94
LM End	0.09	Issue Type +	Ma	Location *	LS
Category	Earthen Levee			GPS Latitude/Longitude	
				Start	End
Item	Slope Stability			39.214217 °	39.214217 °
				-122.002378 °	-122.002378 °
DWR ID	DWR_MA0001_01_f_2016_94				
Comment Code					
S2 : Repair the levee slope damaged by foot traffic and prevent access where possible.					
Inspector Comment					
Repair the erosion along the damaged slope.

View of the slope instability along the landside slope.

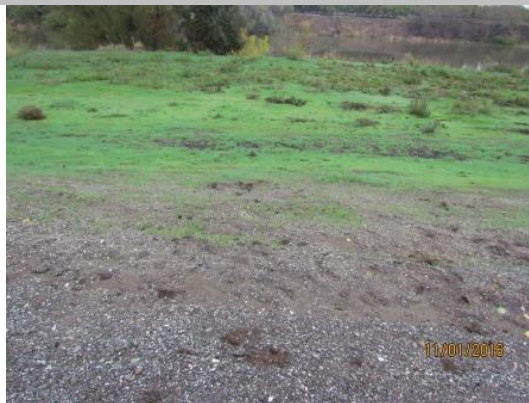
Photo 1 of 1 : SP_2017_MA0001_297_96_20170315_00029.jpg

LM Start	0.23	Rating **	M	Issue No.	96
LM End	0.23	Issue Type +	Ma	Location *	WS
Category	Earthen Levee			GPS Latitude/Longitude	
				Start	End
Item	Erosion / Bank Caving			39.215180 °	39.215180 °
				-122.004712 °	-122.004712 °
DWR ID	DWR_MA0001_01_f_2016_96				
Comment Code					
E2 : Schedule repair of erosion site prior to the next inspection.					
Inspector Comment

View of the erosion along the waterside slope.

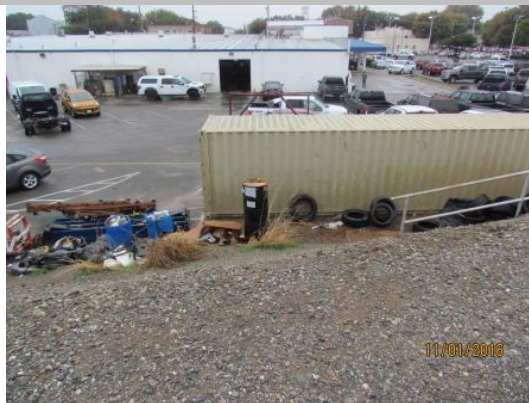
Photo 1 of 1 : SP_2017_MA0001_297_99_20170315_00031.jpg

LM Start	0.42	Rating **	M	Issue No.	99
LM End	0.42	Issue Type +	En	Location *	LS
Category	Earthen Levee			GPS Latitude/Longitude	
				Start	End
Item	Encroachments			39.215863 °	39.215863 °
				-122.008015 °	-122.008015 °
DWR ID	DWR_MA0001_01_f_2016_99				
Comment Code					
EQ : Equipment					
Inspector Comment					
Move the equipment and container at least 10' away from the landside toe.

View of the equipment and shipping container along the landside toe.

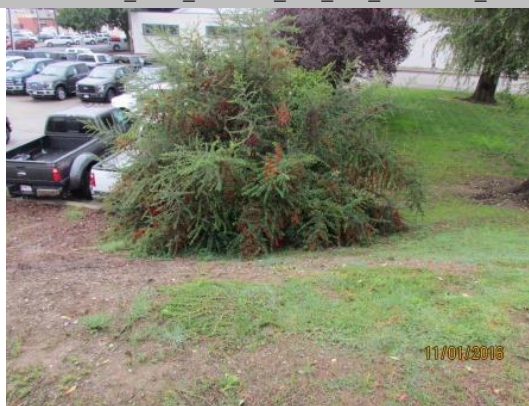
Photo 1 of 1 : SP_2017_MA0001_297_100_20170315_00032.jpg

LM Start	0.49	Rating **	M	Issue No.	100
LM End	0.49	Issue Type +	Ma	Location *	LS
Category	Earthen Levee			GPS Latitude/Longitude	
				Start	End
Item	Trim / Thin Trees			39.215800 °	39.215800 °
				-122.009402 °	-122.009402 °
DWR ID	DWR_MA0001_01_f_2016_100				
Comment Code					
T1 : Trim trees to at least five feet above ground level.					
Inspector Comment

View of an overgrown bush obstructing visibility.

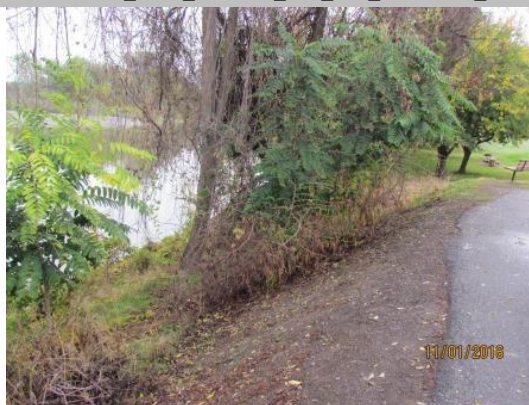
Photo 1 of 1 : SP_2017_MA0001_297_102_20170315_00033.jpg

LM Start	0.67	Rating **	M	Issue No.	102
LM End	0.69	Issue Type +	Ma	Location *	WS
Category	Earthen Levee			GPS Latitude/Longitude	
				Start	End
Item	Trim / Thin Trees			39.216513 °	39.216642 °
				-122.012440 °	-122.012773 °
DWR ID	DWR_MA0001_01_f_2016_102				
Comment Code					
T1 : Trim trees to at least five feet above ground level.					
Inspector Comment

View of a tree obstructing visibility and access.

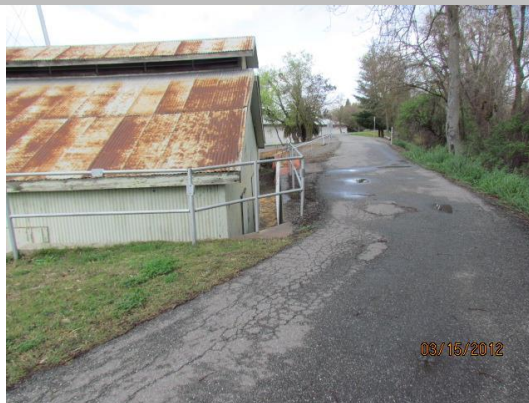
Photo 1 of 1 : SP_2017_MA0001_297_7_20170315_00005.jpg

LM Start	0.67	Rating **	U	Issue No.	7
LM End	0.70	Issue Type +	En	Location *	LS
Category	Earthen Levee			GPS Latitude/Longitude	
				Start	End
Item	Encroachments			39.216533 °	39.216680 °
				-122.012512 °	-122.012907 °
DWR ID	DWR_MA0001_01_s_2012_7				
Comment Code					
BU : Building					
Inspector Comment

View of the buildings along the landside toe.

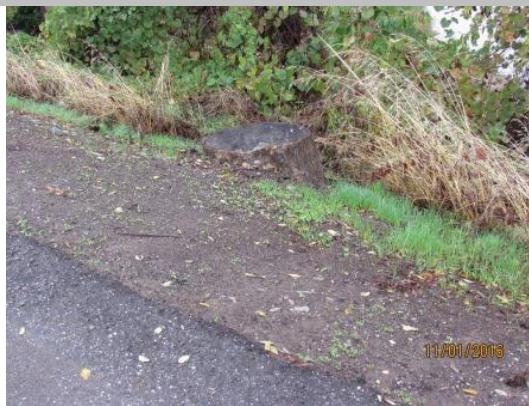
Photo 1 of 1 : SP_2017_MA0001_297_103_20170315_00034.jpg

LM Start	0.68	Rating **	N	Issue No.	103
LM End	0.68	Issue Type +	Ma	Location *	WS
Category	Earthen Levee			GPS Latitude/Longitude	
				Start	End
Item	Trim / Thin Trees			39.216560 °	39.216560 °
				-122.012530 °	-122.012530 °
DWR ID	DWR_MA0001_01_f_2016_103				
Comment Code					
T5 : Tree stumps.					
Inspector Comment

View of a tree stump along the waterside slope.

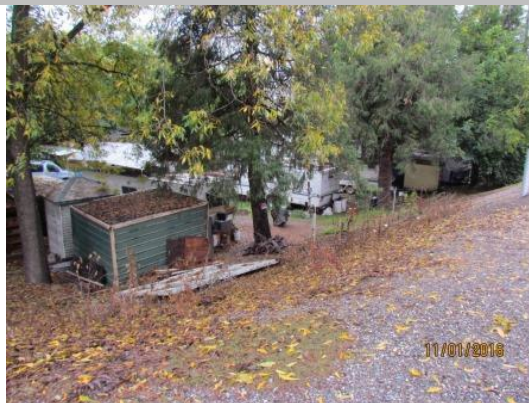
Photo 1 of 1 : SP_2017_MA0001_297_8_20170315_00006.jpg

LM Start	0.79	Rating **	U	Issue No.	8
LM End	0.93	Issue Type +	En	Location *	LS
Category	Earthen Levee			GPS Latitude/Longitude	
				Start	End
Item	Encroachments			39.217282 °	39.218215 °
				-122.014290 °	-122.016538 °
DWR ID	DWR_MA0001_01_s_2012_8				
Comment Code					
BU : Building					
Inspector Comment

View of a building along the landside toe.

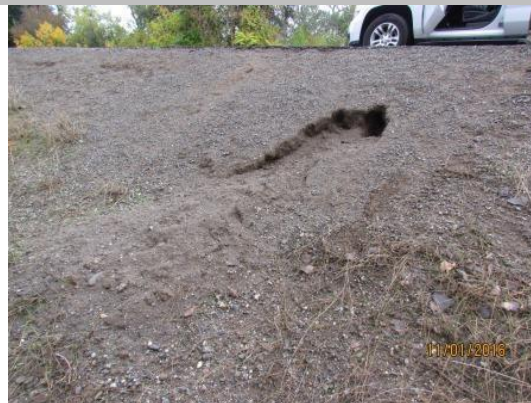
Photo 1 of 1 : SP_2017_MA0001_297_104_20170315_00035.jpg

LM Start	1.11	Rating **	M	Issue No.	104
LM End	1.11	Issue Type +	Ma	Location *	LS
Category	Earthen Levee			GPS Latitude/Longitude	
				Start	End
Item	Slope Stability			39.220728 °	39.220728 °
				-122.015885 °	-122.015885 °
DWR ID	DWR_MA0001_01_f_2016_104				
Comment Code					
S1 : Repair slope instability.					
Inspector Comment

View of a slope instability issue along the landside slope.

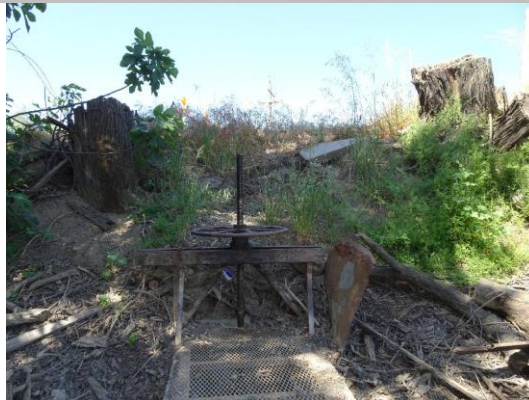
Photo 2 of 3 : UCIP_SP_2017_51822_77033.jpg

LM Start	1.17	Rating **	U	Issue No.	639 (cont)
LM End	1.17	Issue Type +	En	Location *	LS

View of slide gate near WS shoulder.

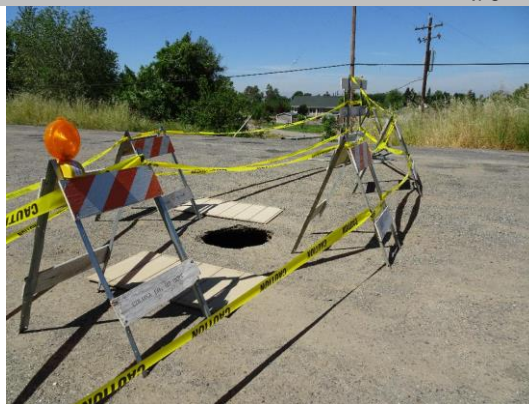
Photo 3 of 3 : UCIP_SP_2017_51822_77033.jpg

LM Start	1.17	Rating **	U	Issue No.	639 (cont)
LM End	1.17	Issue Type +	En	Location *	LS

Sink hole is approximately 10-15 feet in diameter and 10-15 feet deep.

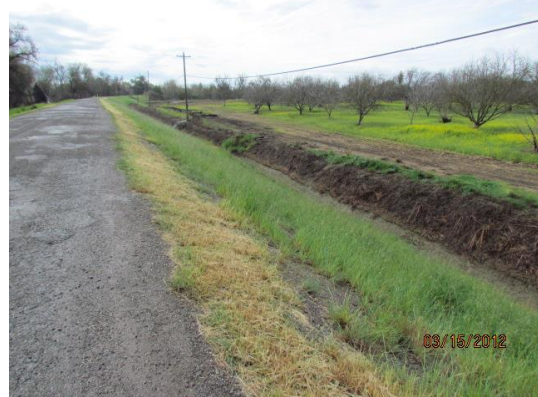
Photo 1 of 1 : SP_2017_MA0001_297_6_20170315_00004.jpg

LM Start	1.20	Rating **	U	Issue No.	6
LM End	1.34	Issue Type +	En	Location *	LS
Category	Earthen Levee			GPS Latitude/Longitude	
				Start	End
Item	Encroachments			39.222119 °	39.224063 °
				-122.015747 °	-122.016080 °
DWR ID	DWR_MA0001_01_s_2012_6				
Comment Code					
DT : Ditch					
Inspector Comment

View of an ag ditch along the landside toe.

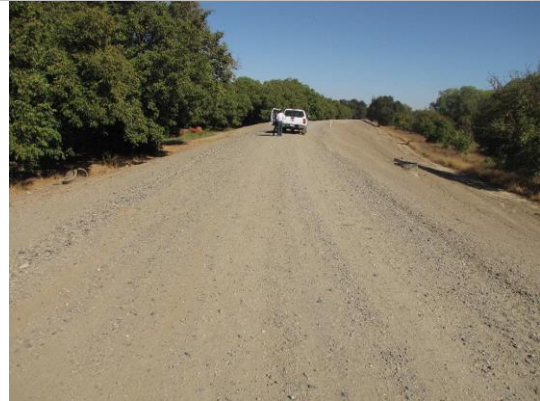
Photo 1 of 3 : UCIP_SP_2017_51853_70071.jpg

FS_ID:51853
DS_ID:17565
EP_NO: 9487
Repair Type: Non-Urgent
Crossing Status: Found
UCIP Comments: 5/3/2017 Ws end still partially plugged. (DWR Sutter Yard- A Freitag) 10/24/2016 Ws pipe end still plugged. (DWR Sutter Yard- A Freitag) 4/25/2016 WS pipe end still plugged with soil. rest of pipe appears in good condition. 4/20/2015 WS pipe end plugged about 50% by soil. 6/18/2014 Same as last inspection. 12/17/2013 Same as last inspection. 7/18/2013 WS pipe end has been reformed but is still partially blocked with dirt and debris. 10/18/2012 WS-remove dirt and debris in riser. Outlet deformed and blocked over 50%. Burrow activity near outlet on waterward slope. Debris around concrete section on landward side. This crossing was listed in the USACE Periodic Inspections as ID# USACE_CESPK_MA1C_2010_p_0116 for crossing outlet deformed and clogged with dirt.
FIELD_STRUCT_DESC: 2 of 2: 36-inch corrugated metal drainage pipe through the levee, approximately 12-15 feet below the crown. Slide gates in corrugated metal pipe (CMP) riser on the waterside (WS) slope. Pipe daylights on the landside (LS). (Automatic Board Order (ABO) issued as Permit No. 9487, 1974 - Jimeno Rancho) [Additional Reference(s): DWR Levee Log, 1992. USACE Sacramento O&M Manual 137, August 1955, (Station 103+18)].

LM Start	1.92	Rating **	M	Issue No.	641 (cont)
LM End	1.92	Issue Type +	Ma	Location *	LS

View of levee crown and slopes looking upstream at crossing.

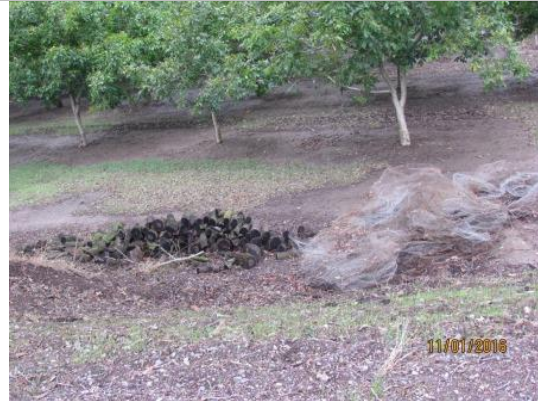
Photo 1 of 1 : SP_2017_MA0001_297_106_20170315_00038.jpg

LM Start	2.23	Rating **	M	Issue No.	106
LM End	2.23	Issue Type +	En	Location *	LS
Category	Earthen Levee			GPS Latitude/Longitude	
				Start	End
Item	Encroachments			39.235880 °	39.235880 °
				-122.013045 °	-122.013045 °
DWR ID	DWR_MA0001_01_f _ 2016_106				
Comment Code					
FW : Firewood					
Inspector Comment					
Remove the chicken wire and firewood from the landside toe.

View of the firewood along the landside toe.

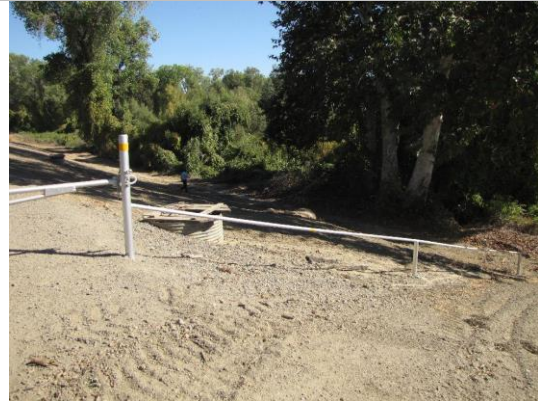
Photo 2 of 3 : UCIP_SP_2017_51854_70079.jpg

FS_ID:51854
DS_ID:16429
EP_NO: 9472
Repair Type: Non-Urgent
Crossing Status: Found
UCIP Comments: 5/3/2017 LS inlet partially plugged with soil. Some debris still present inside riser. (DWR Sutter Yard-AFreitag)10/24/2016 Debris still inside of riser.(DWR Sutter Yard-AFreitag)4/25/2016 Pipe still inside of riser and LS end plugged about 50% by soil.4/20/2015 Same as last inspection.6/18/2014 Same as last inspection.12/17/2013 Same as last inspection.7/18/2013 Same as last inspection.10/18/12 Remove debris from riser. Landward inlet is blocked by over 50%. This crossing was listed in the USACE Periodic Inspections as ID# USACE_CESPK_MA1C_2010_p_0128 for sediment build up at inlet (landward side) and debris inside riser.
FIELD_STRUCT_DESC: 54-inch corrugated metal drainage pipe through the levee, approximately 12-15 feet below the crown. Slide gate in corrugated metal pipe (CMP) riser on the waterside (WS) slope. 48-inch CMP at landside (LS) slope. This crossing crosses the levee at an angle. (Automatic Board Order (ABO) issued as Permit No. 9472, 1974 - Ballard)) [Additional Reference(s): DWR Levee Log, 1992. USACE Sacramento O&M Manual 137, August 1955, (Station 120+00)].

LM Start	2.23	Rating **	M	Issue No.	642 (cont)
LM End	2.23	Issue Type +	Ma	Location *	LS

View of WS looking at slope and channel.

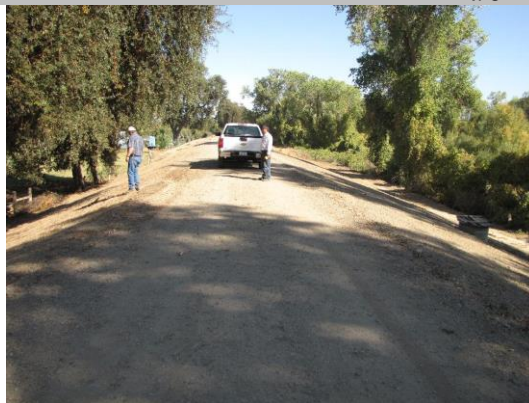
Photo 1 of 3 : UCIP_SP_2017_51855_70085.jpg

FS_ID:51855
DS_ID:16428
EP_NO: 9467
Repair Type: Non-Urgent
Crossing Status: Found
UCIP Comments: 5/3/2017 Abandoned- needs to be done so properly. (DWR Sutter Yard- A Freitag)10/24/2016 Abandoned.(DWR Sutter Yard- A Freitag)4/25/2016 Abandoned crossing. Unable to locate any WS and LS pipe ends.4/20/2015 Same as last inspection.6/18/2014 Same as last inspection.12/17/2013 Same as last inspection.7/18/2013 Same as last inspection.10/18/2012 Only riser visible. Debris and sediment blocking gate. Gate inside riser is buried and non-functional. If crossing is abandoned, owner needs to properly abandon. This crossing was listed in the USACE Periodic Inspections as ID# USACE_CESPK_MA1C_2010_p_0132 no culvert through the levee is visible here.
FIELD_STRUCT_DESC: *ABANDONED* 24-inch corrugated metal drainage pipe through the levee, approximately 12-15 feet below the crown. Slide gate in CM pipe riser on the waterside (WS) slope. No signs of inlet visible on the landside (LS). (Automatic Board Order (ABO) issued as Permit No. 9467, 1974 - Lovell E. Spurgeon)

LM Start	2.25	Rating **	M	Issue No.	643 (cont)
LM End	2.25	Issue Type +	Ma	Location *	LS

Overview of levee crown looking upstream at crossing.

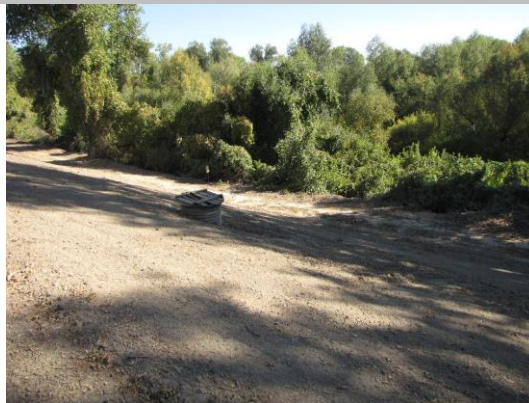
Photo 2 of 3 : UCIP_SP_2017_51855_70084.jpg

View of WS slope and toe.

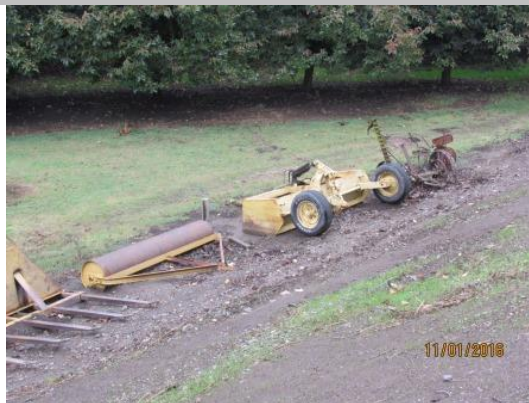
Photo 1 of 1 : SP_2017_MA0001_297_107_20170315_00039.jpg

LM Start	2.36	Rating **	M	Issue No.	107
LM End	2.36	Issue Type +	En	Location *	LS
Category	Earthen Levee			GPS Latitude/Longitude	
				Start	End
Item	Encroachments			39.237628 °	39.237628 °
				-122.011967 °	-122.011967 °
DWR ID	DWR_MA0001_01_f_2016_107				
Comment Code					
EQ : Equipment					
Inspector Comment

View of the ag equipment along the landside toe.

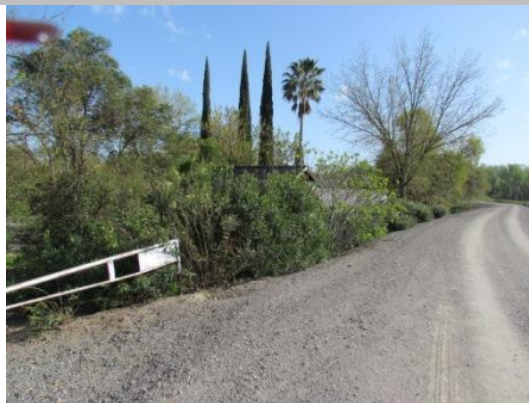
Photo 1 of 1 : SP_2017_MA0001_297_20_20170315_00011.jpg

LM Start	2.53	Rating **	U	Issue No.	20
LM End	2.55	Issue Type +	En	Location *	LS
Category	Earthen Levee			GPS Latitude/Longitude	
				Start	End
Item	Encroachments			39.239750 °	39.239955 °
				-122.010390 °	-122.010090 °
DWR ID	DWR_MA0001_01_s_2012_20				
Comment Code					
BU : Building					
Inspector Comment

View of the house next to the levee.

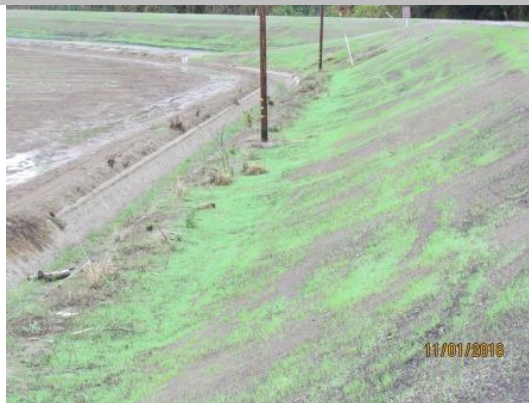
Photo 1 of 1 : SP_2017_MA0001_297_109_20170315_00041.jpg

LM Start	2.81	Rating **	U	Issue No.	109
LM End	2.92	Issue Type +	En	Location *	LS
Category	Earthen Levee			GPS Latitude/Longitude	
				Start	End
Item	Encroachments			39.243467 °	39.244902 °
				-122.008340 °	-122.007867 °
DWR ID	DWR_MA0001_01_f_2016_109				
Comment Code					
DT : Ditch					
Inspector Comment

View of a concrete lined ditch along the landside toe.

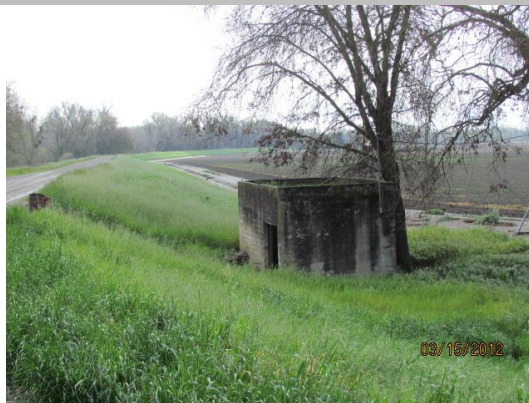
Photo 1 of 1 : SP_2017_MA0001_297_5_20170315_00003.jpg

LM Start	3.05	Rating **	U	Issue No.	5
LM End	3.46	Issue Type +	En	Location *	LS
Category	Earthen Levee			GPS Latitude/Longitude	
				Start	End
Item	Encroachments			39.246813 °	39.252748 °
				-122.008155 °	-122.008320 °
DWR ID	DWR_MA0001_01_s_2012_5				
Comment Code					
DT : Ditch					
Inspector Comment

View of the ag. ditch & concrete building along the landside toe.

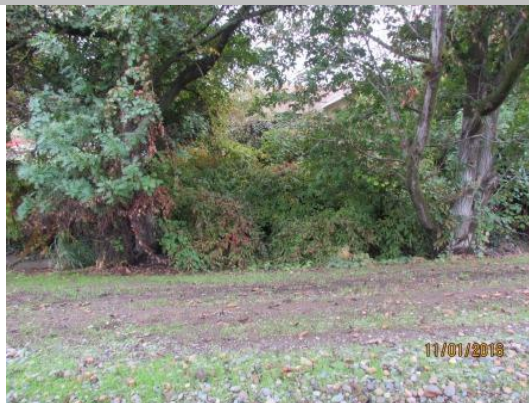
Photo 1 of 1 : SP_2017_MA0001_297_110_20170315_00042.jpg

LM Start	3.08	Rating **	U	Issue No.	110
LM End	3.08	Issue Type +	En	Location *	LS
Category	Earthen Levee			GPS Latitude/Longitude	
				Start	End
Item	Vegetation			39.247273 °	39.247273 °
				-122.008185 °	-122.008185 °
DWR ID	DWR_MA0001_01_f_2016_110				
Comment Code					
V6 : Landscaping					
Inspector Comment

View of the overgrown trees blocking visibility.

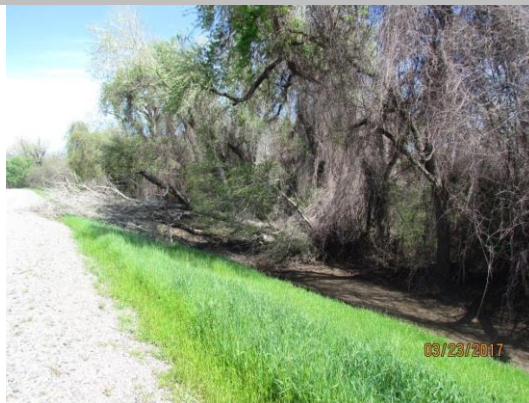
Photo 1 of 1 : SP_2017_MA0001_297_76_20170330_00183.jpg

LM Start	3.25	Rating **	M	Issue No.	76
LM End	3.25	Issue Type +	En	Location *	WS
Category	Earthen Levee			GPS Latitude/Longitude	
				Start	End
Item	Encroachments			39.249658 °	39.249658 °
				-122.008037 °	-122.008037 °
DWR ID	DWR_MA0001_01_s_2017_76				
Comment Code					
TR : Tree or limb					
Inspector Comment					
Remove the trees from the waterside slope and toe.

View of the trees on the waterside slope and toe.

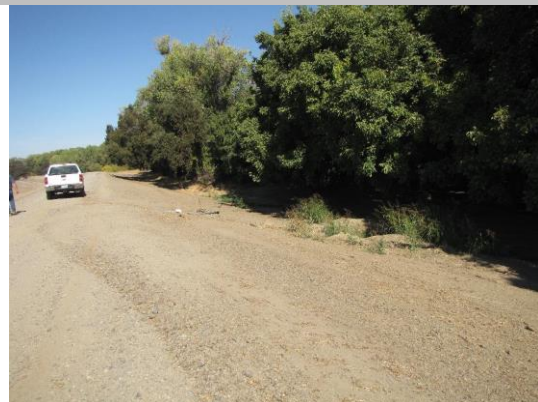
Photo 2 of 3 : UCIP_SP_2017_51859_70109.jpg

View of WS looking upstream.

Item	DWR UCIP LMA Responsibility			39.250843 °	39.250843 °	
				-122.007992 °	-122.007992 °	
DWR ID						
Comment Code						
Inspector Comment						
FS_ID:51859 DS_ID:16426 EP_NO: 9490 Repair Type: Non-Urgent Crossing Status: Found UCIP Comments: 5/3/2017 Sediment build up in WS pipe end. WS slide gate stem bent but it does not affect its operation. (DWR Sutter Yard- A Freitag)10/24/2016 WS slide gate stem is still bent.(DWR Sutter Yard- A Freitag)4/25/2016 WS slide gate is slightly bent. Rest of crossing appears to be in good condition. 4/20/2015 LS inlet still has some minor sediment build up. Needs to be cleaned.6/18/2014 Same as last inspection.12/17/2013 Same as last inspection.7/18/2013 WS slide gate looks to be in good condition but stem is slightly bent. Not sure if bend will hinder gates operation or not. LS inlet is still blocked by minor sediment build up.10/18/2012 LS pipe slightly deformed and sediment build up blocking about 30% of opening; need to check the condition of the slide gate-need photo. Metal marker down. This crossing was listed in the USACE Periodic Inspection as ID# USACE_CESPK_MA1C_2010_p_0187 for sediment build up at landward toe. FIELD_STRUCT_DESC: 36-inch corrugated metal drainage pipe through the levee, approximately 12-15 feet below the crown. Slide gate in corrugated metal pipe (CMP) riser on the waterside (WS) slope. (Permit No. 9490, 1955 - Charles & Virginia Yerxa) [Additional Reference(s): DWR Levee Log, 1992. USACE Sacramento O&M Manual 137, August 1955, (Station 177+67)]. FS Date: 5/19/2017 1:53:31 PM

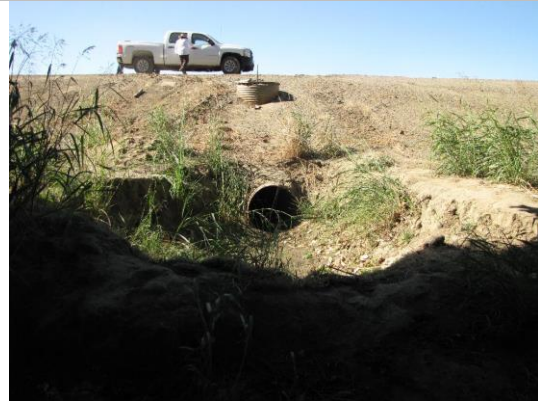
Photo 3 of 3 : UCIP_SP_2017_51859_70111.jpg

View of WS slope, riser with slide gate, and outlet.

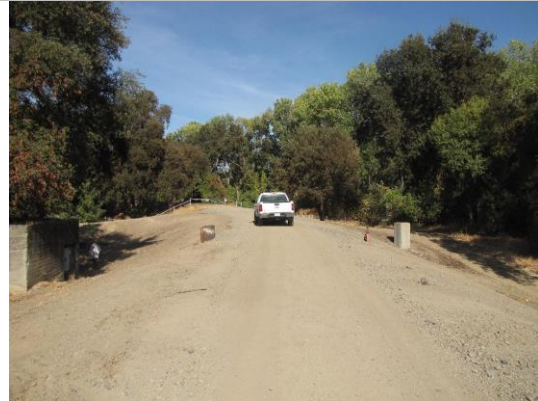
Photo 1 of 3 : UCIP_SP_2017_51860_70222.jpg

Comment Code					
Inspector Comment					
FS_ID:51860 DS_ID:16436 EP_NO: 4213 Repair Type: Urgent Crossing Status: Found UCIP Comments: 5/3/2017 Sinkhole still present next to concrete structure on LS. (DWR Sutter Yard- AFreitag)10/24/2016 Pump is on WS. Sinkhole still present over pipe alignment next to the concrete building.(DWR Sutter Yard- AFreitag)4/25/2016 No repairs have been made since last inspection. Sink holes are still present above pipe next to concrete building on LS. (DWR Sutter Yard - afreitag)4/20/2015 Sink hole over pipe alignment on LS up against the concrete building. Need to dig up pipe and see if its leaking. (DWR Sutter Yard - afreitag)6/23/2014 Same as last inspection. (DWR Sutter Yard - afreitag)6/18/2014 Same as last inspection. (DWR Sutter Yard - afreitag)12/17/2013 Same as last inspection. (DWR Sutter Yard - afreitag)7/18/2013 Same as last inspection. (DWR Sutter Yard - afreitag)10/19/2012 Recommend adding door to LS concrete structure. Riser located on landward side is damaged. This crossing was listed in the USACE Periodic Inspection as ID# USACE_CESPK_MA1C_2010_p_0194 no issues logged. (DWR UCIP - omagana) FIELD_STRUCT_DESC: 24-inch asphalt coated steel irrigation pipe through the levee, approximately 10 feet below the crown. Gate valve on the waterside (WS) shoulder. 1-1/4 inch conduit through the levee. Siphon breaker on the landside (LS) shoulder. Concrete distribution box and control box located on the LS. Pump, walkway, and gate located on the WS berm. (Permit No. 4213, 1973 - Scott Ranch) [Additional Reference(s): DWR Levee Log, 1992]. FS Date: 5/19/2017 1:57:37 PM

Overview of levee crown looking upstream at crossing.

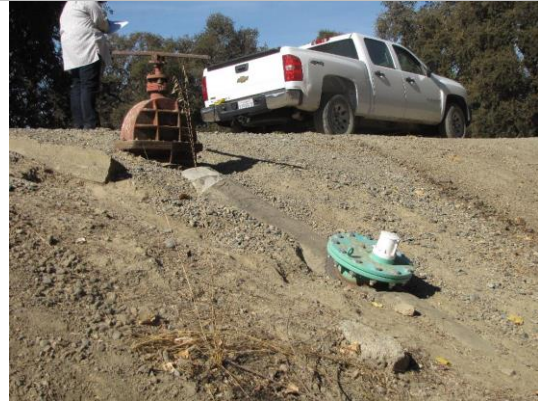
Photo 2 of 3 : UCIP_SP_2017_51860_70221.jpg

Item	DWR UCIP Field Study			39.255803 °	39.255803 °	
				-122.009683 °	-122.009683 °	
DWR ID						
Comment Code						
Inspector Comment						
FS_ID:51860 DS_ID:16436 EP_NO: 4213 Repair Type: Urgent Crossing Status: Found UCIP Comments: 5/3/2017 Sinkhole still present next to concrete structure on LS. (DWR Sutter Yard- AFreitag)10/24/2016 Pump is on WS. Sinkhole still present over pipe alignment next to the concrete building.(DWR Sutter Yard- AFreitag)4/25/2016 No repairs have been made since last inspection. Sink holes are still present above pipe next to concrete building on LS. (DWR Sutter Yard - afreitag)4/20/2015 Sink hole over pipe alignment on LS up against the concrete building. Need to dig up pipe and see if its leaking. (DWR Sutter Yard - afreitag)6/23/2014 Same as last inspection. (DWR Sutter Yard - afreitag)6/18/2014 Same as last inspection. (DWR Sutter Yard - afreitag)12/17/2013 Same as last inspection. (DWR Sutter Yard - afreitag)7/18/2013 Same as last inspection. (DWR Sutter Yard - afreitag)10/19/2012 Recommend adding door to LS concrete structure. Riser located on landward side is damaged. This crossing was listed in the USACE Periodic Inspection as ID# USACE_CESPK_MA1C_2010_p_0194 no issues logged. (DWR UCIP - omagana) FIELD_STRUCT_DESC: 24-inch asphalt coated steel irrigation pipe through the levee, approximately 10 feet below the crown. Gate valve on the waterside (WS) shoulder. 1-1/4 inch conduit through the levee. Siphon breaker on the landside (LS) shoulder. Concrete distribution box and control box located on the LS. Pump, walkway, and gate located on the WS berm. (Permit No. 4213, 1973 - Scott Ranch) [Additional Reference(s): DWR Levee Log, 1992]. FS Date: 5/19/2017 1:57:37 PM

Gate valve and exposed section of the pipe located on WS.

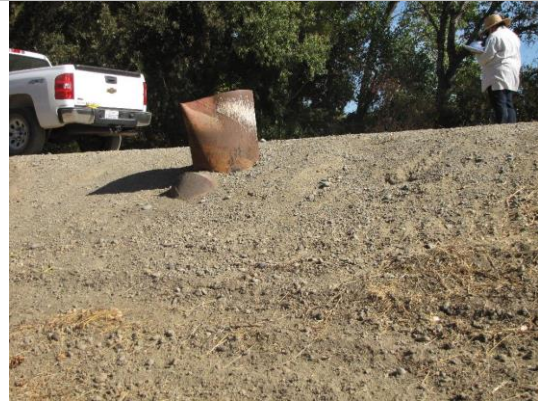
Photo 3 of 3 : UCIP_SP_2017_51860_70220.jpg

Item	DWR UCIP Field Study			39.255803 °	39.255803 °	
				-122.009683 °	-122.009683 °	
DWR ID						
Comment Code						
Inspector Comment						
FS_ID:51860 DS_ID:16436 EP_NO: 4213 Repair Type: Urgent Crossing Status: Found UCIP Comments: 5/3/2017 Sinkhole still present next to concrete structure on LS. (DWR Sutter Yard- AFreitag)10/24/2016 Pump is on WS. Sinkhole still present over pipe alignment next to the concrete building.(DWR Sutter Yard- AFreitag)4/25/2016 No repairs have been made since last inspection. Sink holes are still present above pipe next to concrete building on LS. (DWR Sutter Yard - afreitag)4/20/2015 Sink hole over pipe alignment on LS up against the concrete building. Need to dig up pipe and see if its leaking. (DWR Sutter Yard - afreitag)6/23/2014 Same as last inspection. (DWR Sutter Yard - afreitag)6/18/2014 Same as last inspection. (DWR Sutter Yard - afreitag)12/17/2013 Same as last inspection. (DWR Sutter Yard - afreitag)7/18/2013 Same as last inspection. (DWR Sutter Yard - afreitag)10/19/2012 Recommend adding door to LS concrete structure. Riser located on landward side is damaged. This crossing was listed in the USACE Periodic Inspection as ID# USACE_CESPK_MA1C_2010_p_0194 no issues logged. (DWR UCIP - omagana) FIELD_STRUCT_DESC: 24-inch asphalt coated steel irrigation pipe through the levee, approximately 10 feet below the crown. Gate valve on the waterside (WS) shoulder. 1-1/4 inch conduit through the levee. Siphon breaker on the landside (LS) shoulder. Concrete distribution box and control box located on the LS. Pump, walkway, and gate located on the WS berm. (Permit No. 4213, 1973 - Scott Ranch) [Additional Reference(s): DWR Levee Log, 1992]. FS Date: 5/19/2017 1:57:37 PM

Siphon breaker and section of exposed pipe located on LS shoulder.

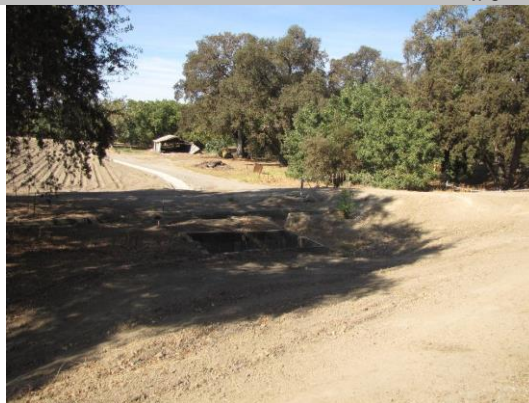
Photo 1 of 3 : UCIP_SP_2017_51861_70125.jpg

FS_ID:51861
DS_ID:16424
EP_NO: 9490
Repair Type: Non-Urgent
Crossing Status: Found
UCIP Comments: 5/3/2017 Abandoned- Needs to be done properly.
(DWR Sutter Yard- A Freitag)10/24/2016 Abandoned. Needs a cover made for the LS distribution box.(DWR Sutter Yard- A Freitag)4/25/2016 ABANDONED crossing and should be abandoned properly. Concrete distribution box on LS is opened on top and could pose a safety hazard with falling.4/20/2015 Same as last inspection. 6/18/2014 Same as last inspection.12/17/2013 Same as last inspection.7/18/2013 Same as last inspection.10/19/2012 Crossing needs to be properly abandoned. This crossing was listed in the USACE Periodic Inspection as ID#
USACE_CESPK_MA1C_2010_p_0194-6 & 7 no issues logged.
FIELD_STRUCT_DESC: *ABANDONED* 36-inch corrugated metal irrigation pipe through the levee, approximately 12-15 feet below the crown. Concrete distribution box with pump system located on the landside (LS). Slide gate on the waterside (WS) slope--removed. 18-inch pipe visible on the LS inside 10-foot by 16 foot concrete box. (Automatic Board Order (ABO) issued as Permit No. 9490, 1974 - Charles T & Virginia W. Yerxa) [Additional Reference(s): DWR Levee Log, 1992. USACE Sacramento O&M Manual 137, August 1955 (Station 197+19)]

Concrete distribution box located on LS.

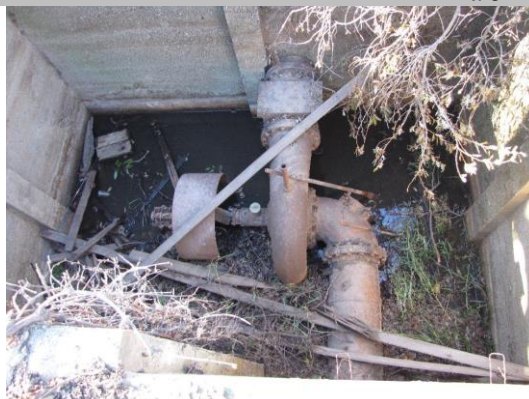
Photo 2 of 3 : UCIP_SP_2017_51861_70123.jpg

Abandoned pump system inside concrete structure located on LS.

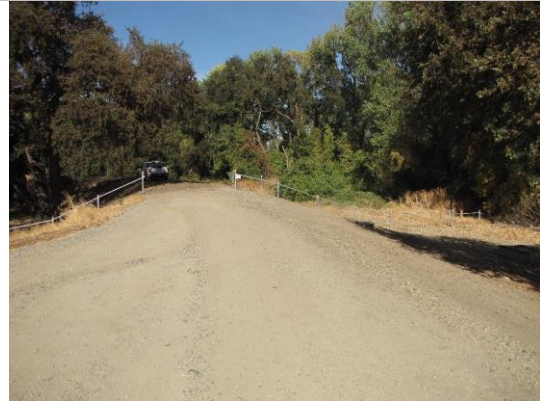
Photo 1 of 3 : UCIP_SP_2017_51862_70128.jpg

FS_ID:51862
DS_ID:16423
EP_NO: 9489
Repair Type: Non-Urgent
Crossing Status: Found
UCIP Comments: 5/3/2017 Appears abandoned- if so needs to be done properly. (DWR Sutter Yard- AFreitag)10/24/2016 Crossing appears abandoned.(DWR Sutter Yard- AFreitag)4/25/2016 Crossing appears abandoned and should be abandoned properly.4/20/2015 Same as last inspection.6/18/2014 Same as last inspection.12/17/2013 Same as last inspection.7/18/2013 Same as last inspection.10/19/2012 Slide gate wheel handle missing. Clear debris from CMP riser. This crossing was listed in the USACE Periodic Inspection as ID# USACE_CESPK_MA1C_2010_p_0196 for access box contains backfilled (permanently shut) and outlet located on landside has sediment build up.
FIELD_STRUCT_DESC: 36-inch corrugated metal irrigation pipe through the levee at an unknown depth below the crown. Slide gate in corrugated metal pipe (CMP) riser on the waterside (WS) slope. 6-foot by 6-foot concrete box on the WS berm. Additional 12-inch pipe inside concrete distribution box. (Automatic Board Order (ABO) issued as Permit No. 9489, 1974 - Mayfair Farms Inc.) [Additional Reference(s): DWR Levee Log, 1992. USACE Sacramento O&M Manual 137, August 1955, (Station 198+00)].

View of crossing looking upstream. Concrete box located on the WS.

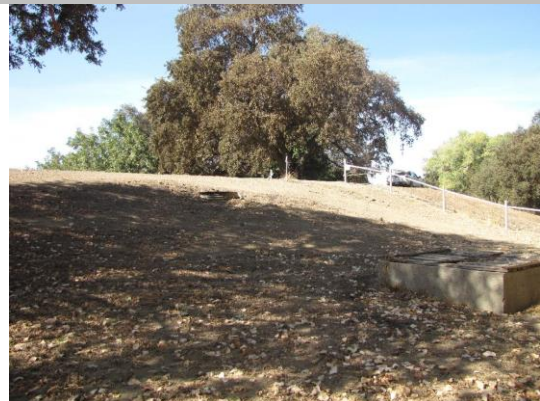
Photo 2 of 3 : UCIP_SP_2017_51862_70131.jpg

View of concrete distribution box and CMP riser located on WS.

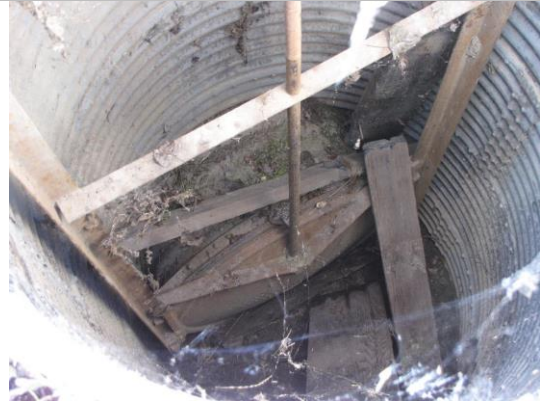
Photo 3 of 3 : UCIP_SP_2017_51862_70126.jpg

Item	DWR UCIP Field Study			39.256203 °	39.256203 °	
				-122.009940 °	-122.009940 °	
DWR ID						
Comment Code						
Inspector Comment						
FS_ID:51862						
DS_ID:16423						
EP_NO: 9489						
Repair Type: Non-Urgent						
Crossing Status: Found						
UCIP Comments: 5/3/2017 Appears abandoned- if so needs to be done properly. (DWR Sutter Yard- AFreitag)10/24/2016 Crossing appears abandoned.(DWR Sutter Yard- AFreitag)4/25/2016 Crossing appears abandoned and should be abandoned properly.4/20/2015 Same as last inspection.6/18/2014 Same as last inspection.12/17/2013 Same as last inspection.7/18/2013 Same as last inspection.10/19/2012 Slide gate wheel handle missing. Clear debris from CMP riser. This crossing was listed in the USACE Periodic Inspection as ID# USACE_CESPK_MA1C_2010_p_0196 for access box contains backfilled (permanently shut) and outlet located on landside has sediment build up.						
FIELD_STRUCT_DESC: 36-inch corrugated metal irrigation pipe through the levee at an unknown depth below the crown. Slide gate in corrugated metal pipe (CMP) riser on the waterside (WS) slope. 6-foot by 6-foot concrete box on the WS berm. Additional 12-inch pipe inside concrete distribution box. (Automatic Board Order (ABO) issued as Permit No. 9489, 1974 - Mayfair Farms Inc.) [Additional Reference(s): DWR Levee Log, 1992. USACE Sacramento O&M Manual 137, August 1955, (Station 198+00)].

WS-Inside view of CMP riser located on waterward slope.

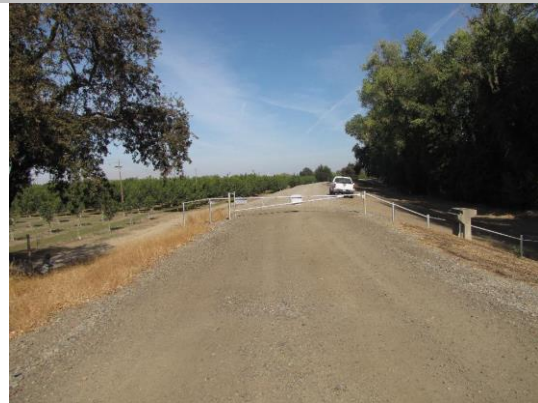
Photo 1 of 3 : UCIP_SP_2017_51864_70137.jpg

Comment Code					
Inspector Comment					
FS_ID:51864 DS_ID:16422 EP_NO: N/A Repair Type: Non-Urgent Crossing Status: Found UCIP Comments: 5/3/2017 Appears abandoned- needs to be done so properly. (DWR Sutter Yard- A/Freitag)10/24/2016 Appears to be abandoned.(DWR Sutter Yard- A/Freitag)4/25/2016 Appears to be an abandoned crossing. 4/20/2015 Debrs is still blocking gate. Appears to be an abandoned crossing.6/18/2014 Same as last inspection.12/17/2013 Same as last inspection.7/18/2013 Wheel to operate slide gate has been replaced but gate is still blocked by debris.10/19/2012 WS-wheel to operate slide gate missing, walkway has been removed; burrow activity near structure; debris in concrete distribution box WS blocking gate. This crossing was listed in the USACE Periodic Inspection as ID# USACE_CESPK_MA1C_2010_p_0207 the wheel to operate sluice gate missing. FIELD_STRUCT_DESC: *ABANDONED* 24-inch drainage pipe of an unknown material through the levee, unknown depth below the crown. Walkway to slide gate on the waterside (WS) end. Walkway has been removed. Flap gate in concrete distribution box at the landside (LS) toe. [Additional Reference(s): DWR Levee Log, 1992]. FS Date: 5/19/2017 2:05:36 PM

View of levee crown looking upstream at crossing.

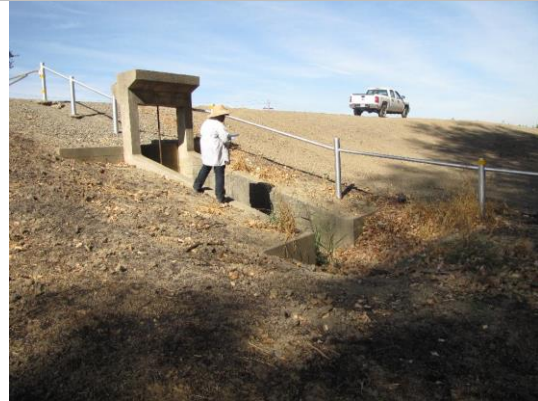
Photo 2 of 3 : UCIP_SP_2017_51864_70139.jpg

FS_ID:51864
DS_ID:16422
EP_NO: N/A
Repair Type: Non-Urgent
Crossing Status: Found
UCIP Comments: 5/3/2017 Appears abandoned- needs to be done so properly. (DWR Sutter Yard- AFreitag)10/24/2016 Appears to be abandoned.(DWR Sutter Yard- AFreitag)4/25/2016 Appears to be an abandoned crossing. 4/20/2015 Debris is still blocking gate. Appears to be an abandoned crossing.6/18/2014 Same as last inspection.12/17/2013 Same as last inspection.7/18/2013 Wheel to operate slide gate has been replaced but gate is still blocked by debris.10/19/2012 WS-wheel to operate slide gate missing, walkway has been removed; burrow activity near structure; debris in concrete distribution box WS blocking gate. This crossing was listed in the USACE Periodic Inspection as ID# USACE_CESPK_MA1C_2010_p_0207 the wheel to operate sluice gate missing.
FIELD_STRUCT_DESC: *ABANDONED* 24-inch drainage pipe of an unknown material through the levee, unknown depth below the crown. Walkway to slide gate on the waterside (WS) end. Walkway has been removed. Flap gate in concrete distribution box at the landside (LS) toe. [Additional Reference(s): DWR Levee Log, 1992].

View of WS slope with concrete structure.

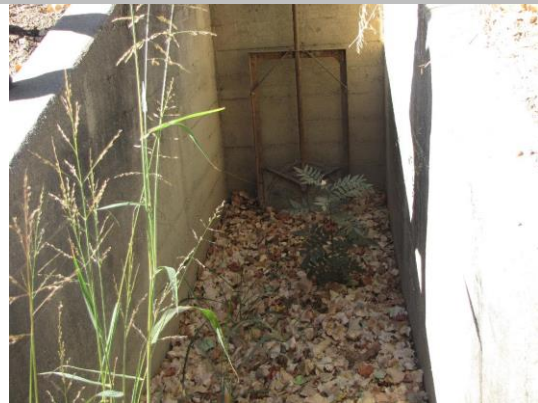
Photo 3 of 3 : UCIP_SP_2017_51864_70138.jpg

View of slide gate located on WS.

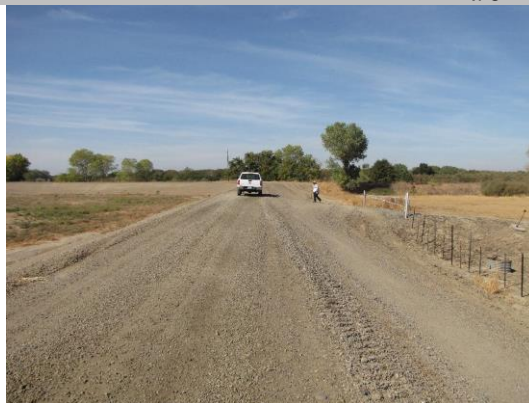
Photo 1 of 3 : UCIP_SP_2017_51865_70144.jpg

Comment Code					
Inspector Comment					
FS_ID:51865 DS_ID:16421 EP_NO: 9475 Repair Type: Non-Urgent Crossing Status: Found UCIP Comments: 5/3/2017 Abandoned- only WS standpipe visible. (DWR Sutter Yard- A Freitag)10/24/2016 Appears to be abandoned.(DWR Sutter Yard- A Freitag)4/25/2016 Abandoned crossing. Only WS standpipe is visible.4/20/2015 Same as last inspection.6/18/2014 Same as last inspection.12/17/2013 Same as last inspection.7/18/2013 Same as last inspection.10/19/2012 Burrow activity; limited visibility of this crossing only on WS riser. This crossing was listed in the USACE Periodic Inspection as ID# USACE_CESPK_MA1C_2010_p_0207 the wheel to operate sluice gate missing. Issue addressed wheel to slide gate has been installed. FIELD_STRUCT_DESC: *ABANDONED* 30-inch corrugated metal irrigation pipe through the levee, 16.1 feet below the crown. Slide gate inside corrugated metal pipe (CMP) riser located on the waterside (WS) end. Line buried on the WS and landside (LS). (Automatic Board Order (ABO) issued as Permit No. 9475, 1974 - Mattie B. Zumwalt Co.) [Additional Reference(s): DWR Levee Log, 1992. USACE Sacramento O&M Manual 137, August 1955, (Station 247+86)]. FS Date: 5/23/2017 9:39:55 AM

Overview of levee crown looking upstream at crossing.

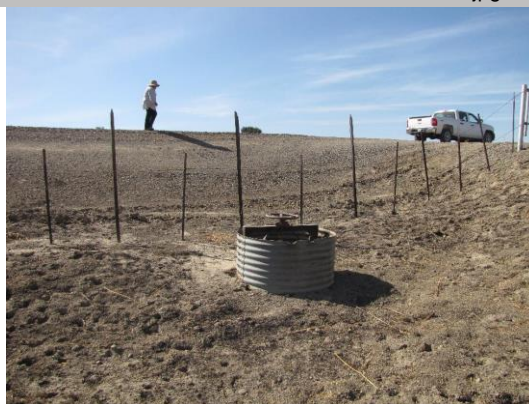
Photo 2 of 3 : UCIP_SP_2017_51865_70147.jpg

Riser with slide gate located on WS toe.

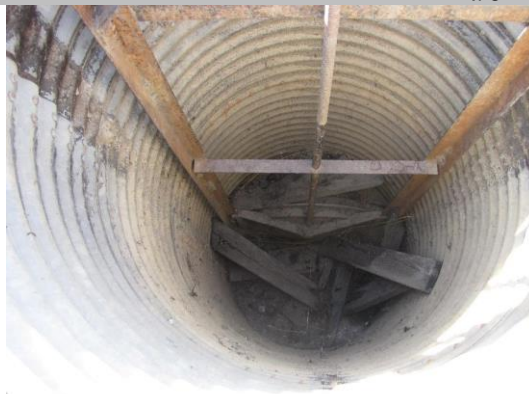
Photo 3 of 3 : UCIP_SP_2017_51865_70146.jpg

Item	DWR UCIP Field Study			39.266435 °	39.266435 °	
				-122.010943 °	-122.010943 °	
DWR ID						
Comment Code						
Inspector Comment						
FS_ID:51865 DS_ID:16421 EP_NO: 9475 Repair Type: Non-Urgent Crossing Status: Found UCIP Comments: 5/3/2017 Abandoned- only WS standpipe visible. (DWR Sutter Yard- A Freitag)10/24/2016 Appears to be abandoned.(DWR Sutter Yard- A Freitag)4/25/2016 Abandoned crossing. Only WS standpipe is visible.4/20/2015 Same as last inspection.6/18/2014 Same as last inspection.12/17/2013 Same as last inspection.7/18/2013 Same as last inspection.10/19/2012 Burrow activity; limited visibility of this crossing only on WS riser. This crossing was listed in the USACE Periodic Inspection as ID# USACE_CESPK_MA1C_2010_p_0207 the wheel to operate sluice gate missing. Issue addressed wheel to slide gate has been installed. FIELD_STRUCT_DESC: *ABANDONED* 30-inch corrugated metal irrigation pipe through the levee, 16.1 feet below the crown. Slide gate inside corrugated metal pipe (CMP) riser located on the waterside (WS) end. Line buried on the WS and landside (LS). (Automatic Board Order (ABO) issued as Permit No. 9475, 1974 - Mattie B. Zumwalt Co.) [Additional Reference(s): DWR Levee Log, 1992. USACE Sacramento O&M Manual 137, August 1955, (Station 247+86)]. FS Date: 5/23/2017 9:39:55 AM

WS--Woody debris inside riser blocking gate.

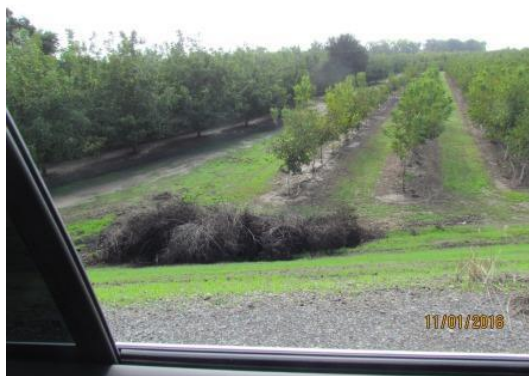
Photo 1 of 1 : SP_2017_MA0001_297_112_20170315_00044.jpg

LM Start	4.85	Rating **	M	Issue No.	112
LM End	4.85	Issue Type +	En	Location *	LS
Category	Earthen Levee			GPS Latitude/Longitude	
				Start	End
Item	Encroachments			39.265738 °	39.265738 °
				-122.013880 °	-122.013880 °
DWR ID	DWR_MA0001_01_f_2016_112				
Comment Code					
PR : Prunings					
Inspector Comment					
Remove prunings from the landside toe.

View of the prunings along the landside toe.

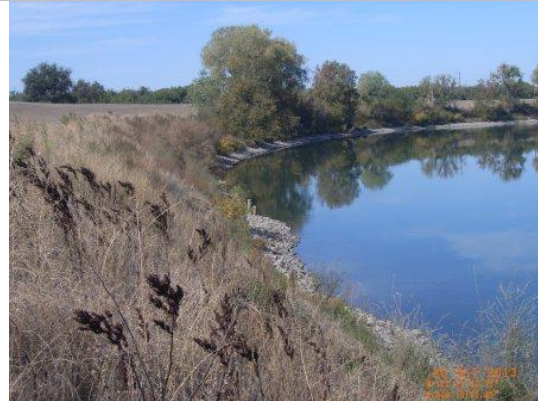
Photo 1 of 1 : SP_2017_MA0001_297_3_20170315_00002.jpg

LM Start	4.86	Rating **	M	Issue No.	3
LM End	5.26	Issue Type +	Ma	Location *	WS
Category	Supplemental			GPS Latitude/Longitude	
				Start	End
Item	2015 USACE Erosion Survey, DRAFT			39.265730 °	39.266315 °
				-122.014925 °	-122.020682 °
DWR ID	DWR_MA0001_01_s _ 2016_3				
Comment Code					
Inspector Comment					
2009 - Slump in the middle of the section has left a vertical section on the bank. 2010 - Old cobble site unraveling, site extended downstream. 2015: Last observed in 2013. [2015 Site ID: SAC_151-0_R]

USACE 2013 Photo #1

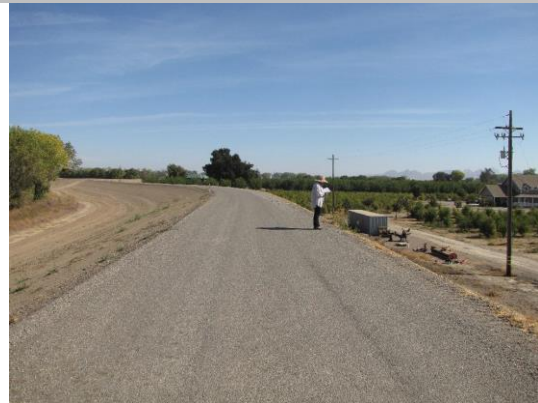
Photo 1 of 3 : UCIP_SP_2017_51868_70150.jpg

Comment Code					
Inspector Comment					
FS_ID:51868 DS_ID:16420 EP_NO: 4903 Repair Type: Non-Urgent Crossing Status: Indicator Found UCIP Comments: 5/3/2017 Appears abandoned- if so needs to be done properly. (DWR Sutter Yard- A/Freitag)10/24/2016 appears to be abandoned.(DWR Sutter Yard- A/Freitag)4/25/2016 Appears to be an abandoned crossing.4/20/2015 Suspect that pump on LS is a well pump and has nothing to do with this crossing.6/18/2014 Same as last inspection.12/17/2013 Same as last inspection.7/18/2013 Same as last inspection.10/19/2012 Unable to locate siphon breaker, pump on LS; unable to tell if pump system is part of appurtenances. This crossing was listed in the USACE Periodic Inspection as ID# USACE_CESPK_MA1C_2010_p_0233 for utility pole and 8 inch steel riser located on landward toe. FIELD_STRUCT_DESC: 12-inch asphalt coated steel irrigation pipe through the levee, approximately 18-20 feet below the crown. Siphon breaker in 24-inch corrugated metal pipe (CMP) riser on the landside (LS) shoulder--not found. 3-inch electrical conduit through the levee--not found. Utility pole visible on the LS. Well station visible on the LS. No appurtenances visible on the waterside (WS). (Permit No. 4903, 4903-A, 1966 - Mattie B. Zumwalt Company, Inc.) [Additional Reference(s): DWR Levee Log, 1992]. FS Date: 5/23/2017 9:41:40 AM

View of levee crown looking downstream at crossing.

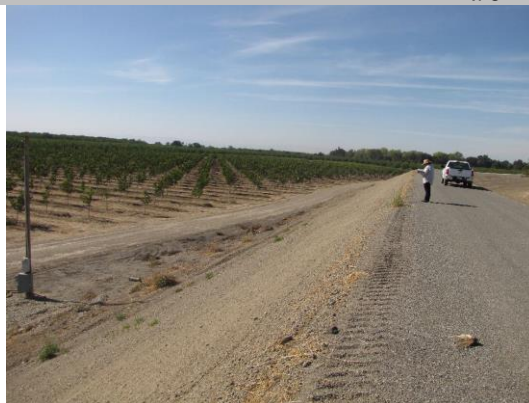
Photo 2 of 3 : UCIP_SP_2017_51868_70149.jpg

FS_ID:51868
DS_ID:16420
EP_NO: 4903
Repair Type: Non-Urgent
Crossing Status: Indicator Found
UCIP Comments: 5/3/2017 Appears abandoned- if so needs to be done properly. (DWR Sutter Yard- A Freitag)10/24/2016 appears to be abandoned.(DWR Sutter Yard- A Freitag)4/25/2016 Appears to be an abandoned crossing.4/20/2015 Suspect that pump on LS is a well pump and has nothing to do with this crossing.6/18/2014 Same as last inspection.12/17/2013 Same as last inspection.7/18/2013 Same as last inspection.10/19/2012 Unable to locate siphon breaker, pump on LS; unable to tell if pump system is part of appurtenances. This crossing was listed in the USACE Periodic Inspection as ID# USACE_CESPK_MA1C_2010_p_0233 for utility pole and 8 inch steel riser located on landward toe.
FIELD_STRUCT_DESC: 12-inch asphalt coated steel irrigation pipe through the levee, approximately 18-20 feet below the crown. Siphon breaker in 24-inch corrugated metal pipe (CMP) riser on the landside (LS) shoulder--not found. 3-inch electrical conduit through the levee--not found. Utility pole visible on the LS. Well station visible on the LS. No appurtenances visible on the waterside (WS). (Permit No. 4903, 4903-A, 1966 - Mattie B. Zumwalt Company, Inc.) [Additional Reference(s): DWR Levee Log, 1992].

View of levee crown looking upstream at crossing.

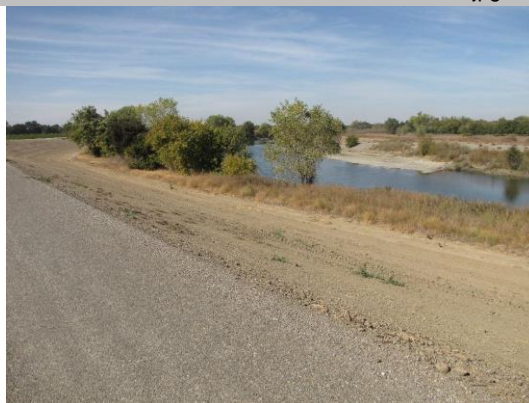
Photo 3 of 3 : UCIP_SP_2017_51868_70148.jpg

View of WS-no visible appurtenances associated with structure.

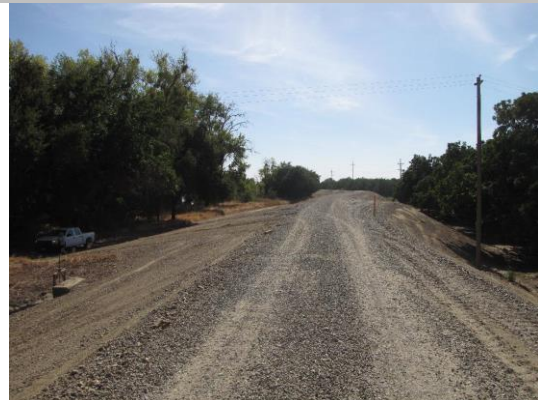
Photo 1 of 3 : UCIP_SP_2017_51869_70154.jpg

Comment Code					
Inspector Comment					
FS_ID:51869 DS_ID:16419 EP_NO: 9476 Repair Type: Non-Urgent Crossing Status: Found UCIP Comments: 5/3/2017 Culvert has sediment build up in it- needs to be cleaned out. (DWR Sutter Yard- AFreitag)10/24/2016 LS outlets becoming over grown with vegetation in the ditch.(DWR Sutter Yard- AFreitag)4/25/2016 WS entry still blocked and wingwalls still cracked.4/20/2015 WS entry still blocked and wingwalls still cracked.6/18/2014 Same as last inspection.12/17/2013 Same as last inspection.7/18/2013 Same as last inspection.10/19/2012 blocked, no entry on WS. This crossing was listed in the USACE Periodic Inspection as ID# USACE_CESPK_MA1C_2010_p_0247 for u/s and d/s wing wall shows some cracking and tilting. FIELD_STRUCT_DESC: 1 of 2: 36-inch corrugated metal irrigation pipe and concrete box culvert through the levee at an unknown depth below the crown. Concrete headwall visible on the landside (LS) toe. (Automatic Board Order (ABO) issued as Permit No. 9476, 1974 - Ohliger) [Additional Reference(s): DWR Levee Log, 1992]. FS Date: 5/23/2017 9:51:10 AM

Overview of levee crown looking downstream at crossing.

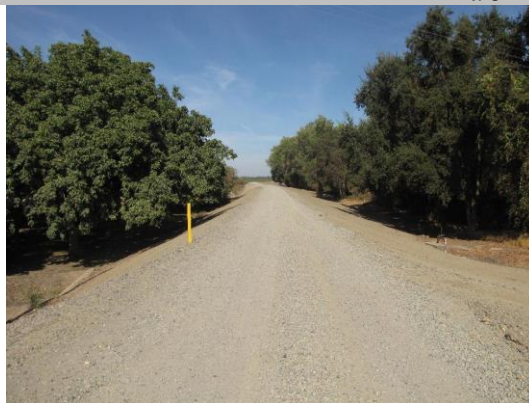
Photo 2 of 3 : UCIP_SP_2017_51869_70152.jpg

Item	DWR UCIP Field Study			39.272069 °		39.272069 °
				-122.023240 °		-122.023240 °
DWR ID						
Comment Code						
Inspector Comment						
FS_ID:51869 DS_ID:16419 EP_NO: 9476 Repair Type: Non-Urgent Crossing Status: Found UCIP Comments: 5/3/2017 Culvert has sediment build up in it- needs to be cleaned out. (DWR Sutter Yard- AFreitag)10/24/2016 LS outlets becoming over grown with vegetation in the ditch.(DWR Sutter Yard- AFreitag)4/25/2016 WS entry still blocked and wingwalls still cracked.4/20/2015 WS entry still blocked and wingwalls still cracked.6/18/2014 Same as last inspection.12/17/2013 Same as last inspection.7/18/2013 Same as last inspection.10/19/2012 blocked, no entry on WS. This crossing was listed in the USACE Periodic Inspection as ID# USACE_CESPK_MA1C_2010_p_0247 for u/s and d/s wing wall shows some cracking and tilting. FIELD_STRUCT_DESC: 1 of 2: 36-inch corrugated metal irrigation pipe and concrete box culvert through the levee at an unknown depth below the crown. Concrete headwall visible on the landside (LS) toe. (Automatic Board Order (ABO) issued as Permit No. 9476, 1974 - Ohliger) [Additional Reference(s): DWR Levee Log, 1992]. FS Date: 5/23/2017 9:51:10 AM

View of crossing looking upstream at crossing.

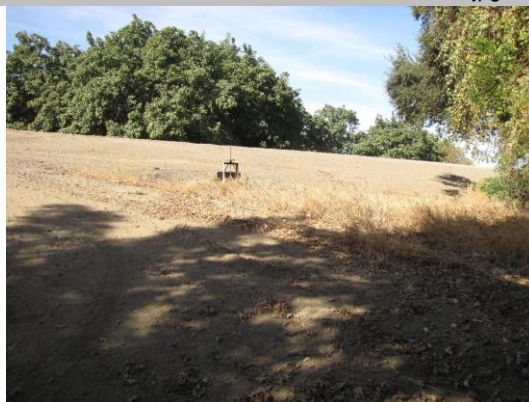
Photo 3 of 3 : UCIP_SP_2017_51869_70156.jpg

View of WS slope and access road. Slide gate is second crossing at this location.

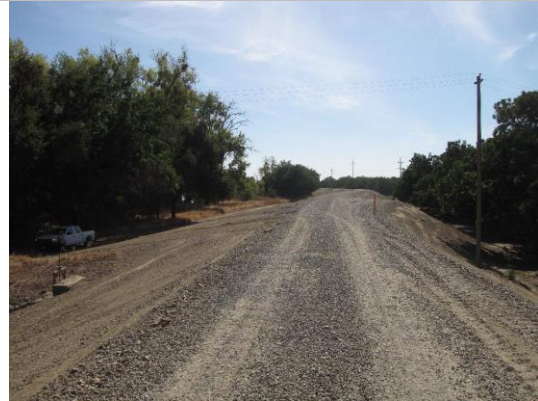
Photo 1 of 3 : UCIP_SP_2017_51870_70162.jpg

Comment Code					
Inspector Comment					
FS_ID:51870 DS_ID:17569 EP_NO: 9476 Repair Type: Non-Urgent Crossing Status: Found UCIP Comments: 5/3/2107 Culvert has sediment build up in it- needs to be cleaned out. (DWR Sutter Yard- AFreitag)10/24/2016 LS outlets becoming overgrown with vegetation in the dtch.(DWR Sutter Yard- AFreitag)4/25/2016 WS entry still blocked and wingwalls still cracked.4/20/2015 WS entry still blocked and wingwalls still cracked.6/18/2014 Same as last inspection.12/17/2013 Same as last inspection.7/18/2013 Same as last inspection.10/19/2012 blocked, no entry on WS. This crossing was listed in the USACE Periodic Inspection as ID# USACE_CESPK_MA1C_2010_p_0247 for u/s and d/s wing wall shows some cracking and tilting. FIELD_STRUCT_DESC: 2 of 2: 36-inch corrugated metal irrigation pipe (15 feet long) and concrete box culvert through the levee at an unknown depth below the crown. Slide gate located on the waterside (WS). Concrete headwall visible on the landside (LS) toe. (Automatic Board Order (ABO) issued as Permit No. 9476-1974, Howard C. & Nadine M. Ohliger) [Additional Reference(s): DWR Levee Log, 1992]. FS Date: 5/23/2017 9:56:33 AM

View of levee crown looking downstream at crossing.

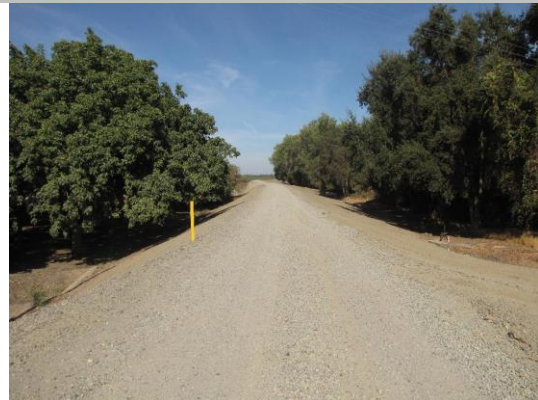
Photo 2 of 3 : UCIP_SP_2017_51870_70161.jpg

View of levee crown looking upstream at crossing.

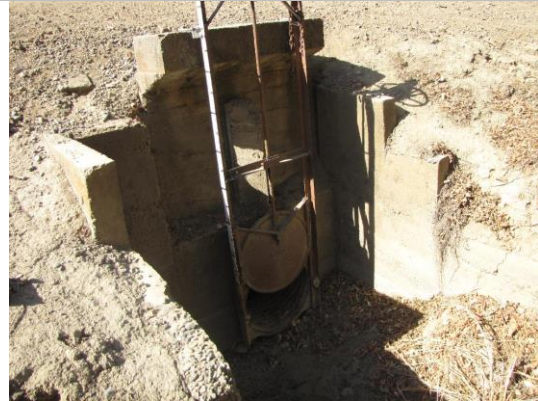
Photo 3 of 3 : UCIP_SP_2017_51870_70160.jpg

Item	DWR UCIP Field Study			39.272069 °	39.272069 °	
				-122.023240 °	-122.023240 °	
DWR ID						
Comment Code						
Inspector Comment						
FS_ID:51870 DS_ID:17569 EP_NO: 9476 Repair Type: Non-Urgent Crossing Status: Found UCIP Comments: 5/3/2107 Culvert has sediment build up in it- needs to be cleaned out. (DWR Sutter Yard- AFreitag)10/24/2016 LS outlets becoming overgrown with vegetation in the dtch.(DWR Sutter Yard- AFreitag)4/25/2016 WS entry still blocked and wingwalls still cracked.4/20/2015 WS entry still blocked and wingwalls still cracked.6/18/2014 Same as last inspection.12/17/2013 Same as last inspection.7/18/2013 Same as last inspection.10/19/2012 blocked, no entry on WS. This crossing was listed in the USACE Periodic Inspection as ID# USACE_CESPK_MA1C_2010_p_0247 for u/s and d/s wing wall shows some cracking and tilting. FIELD_STRUCT_DESC: 2 of 2: 36-inch corrugated metal irrigation pipe (15 feet long) and concrete box culvert through the levee at an unknown depth below the crown. Slide gate located on the waterside (WS). Concrete headwall visible on the landside (LS) toe. (Automatic Board Order (ABO) issued as Permit No. 9476-1974, Howard C. & Nadine M. Ohliger) [Additional Reference(s): DWR Levee Log, 1992]. FS Date: 5/23/2017 9:56:33 AM

Headwall and slide gate located on WS.
